THE ANNUAL CHARGE AGAINST TREATED TIMBER

BULLETIN 40

BY E. F. PADDOCK, CHEMICAL ENGINEER

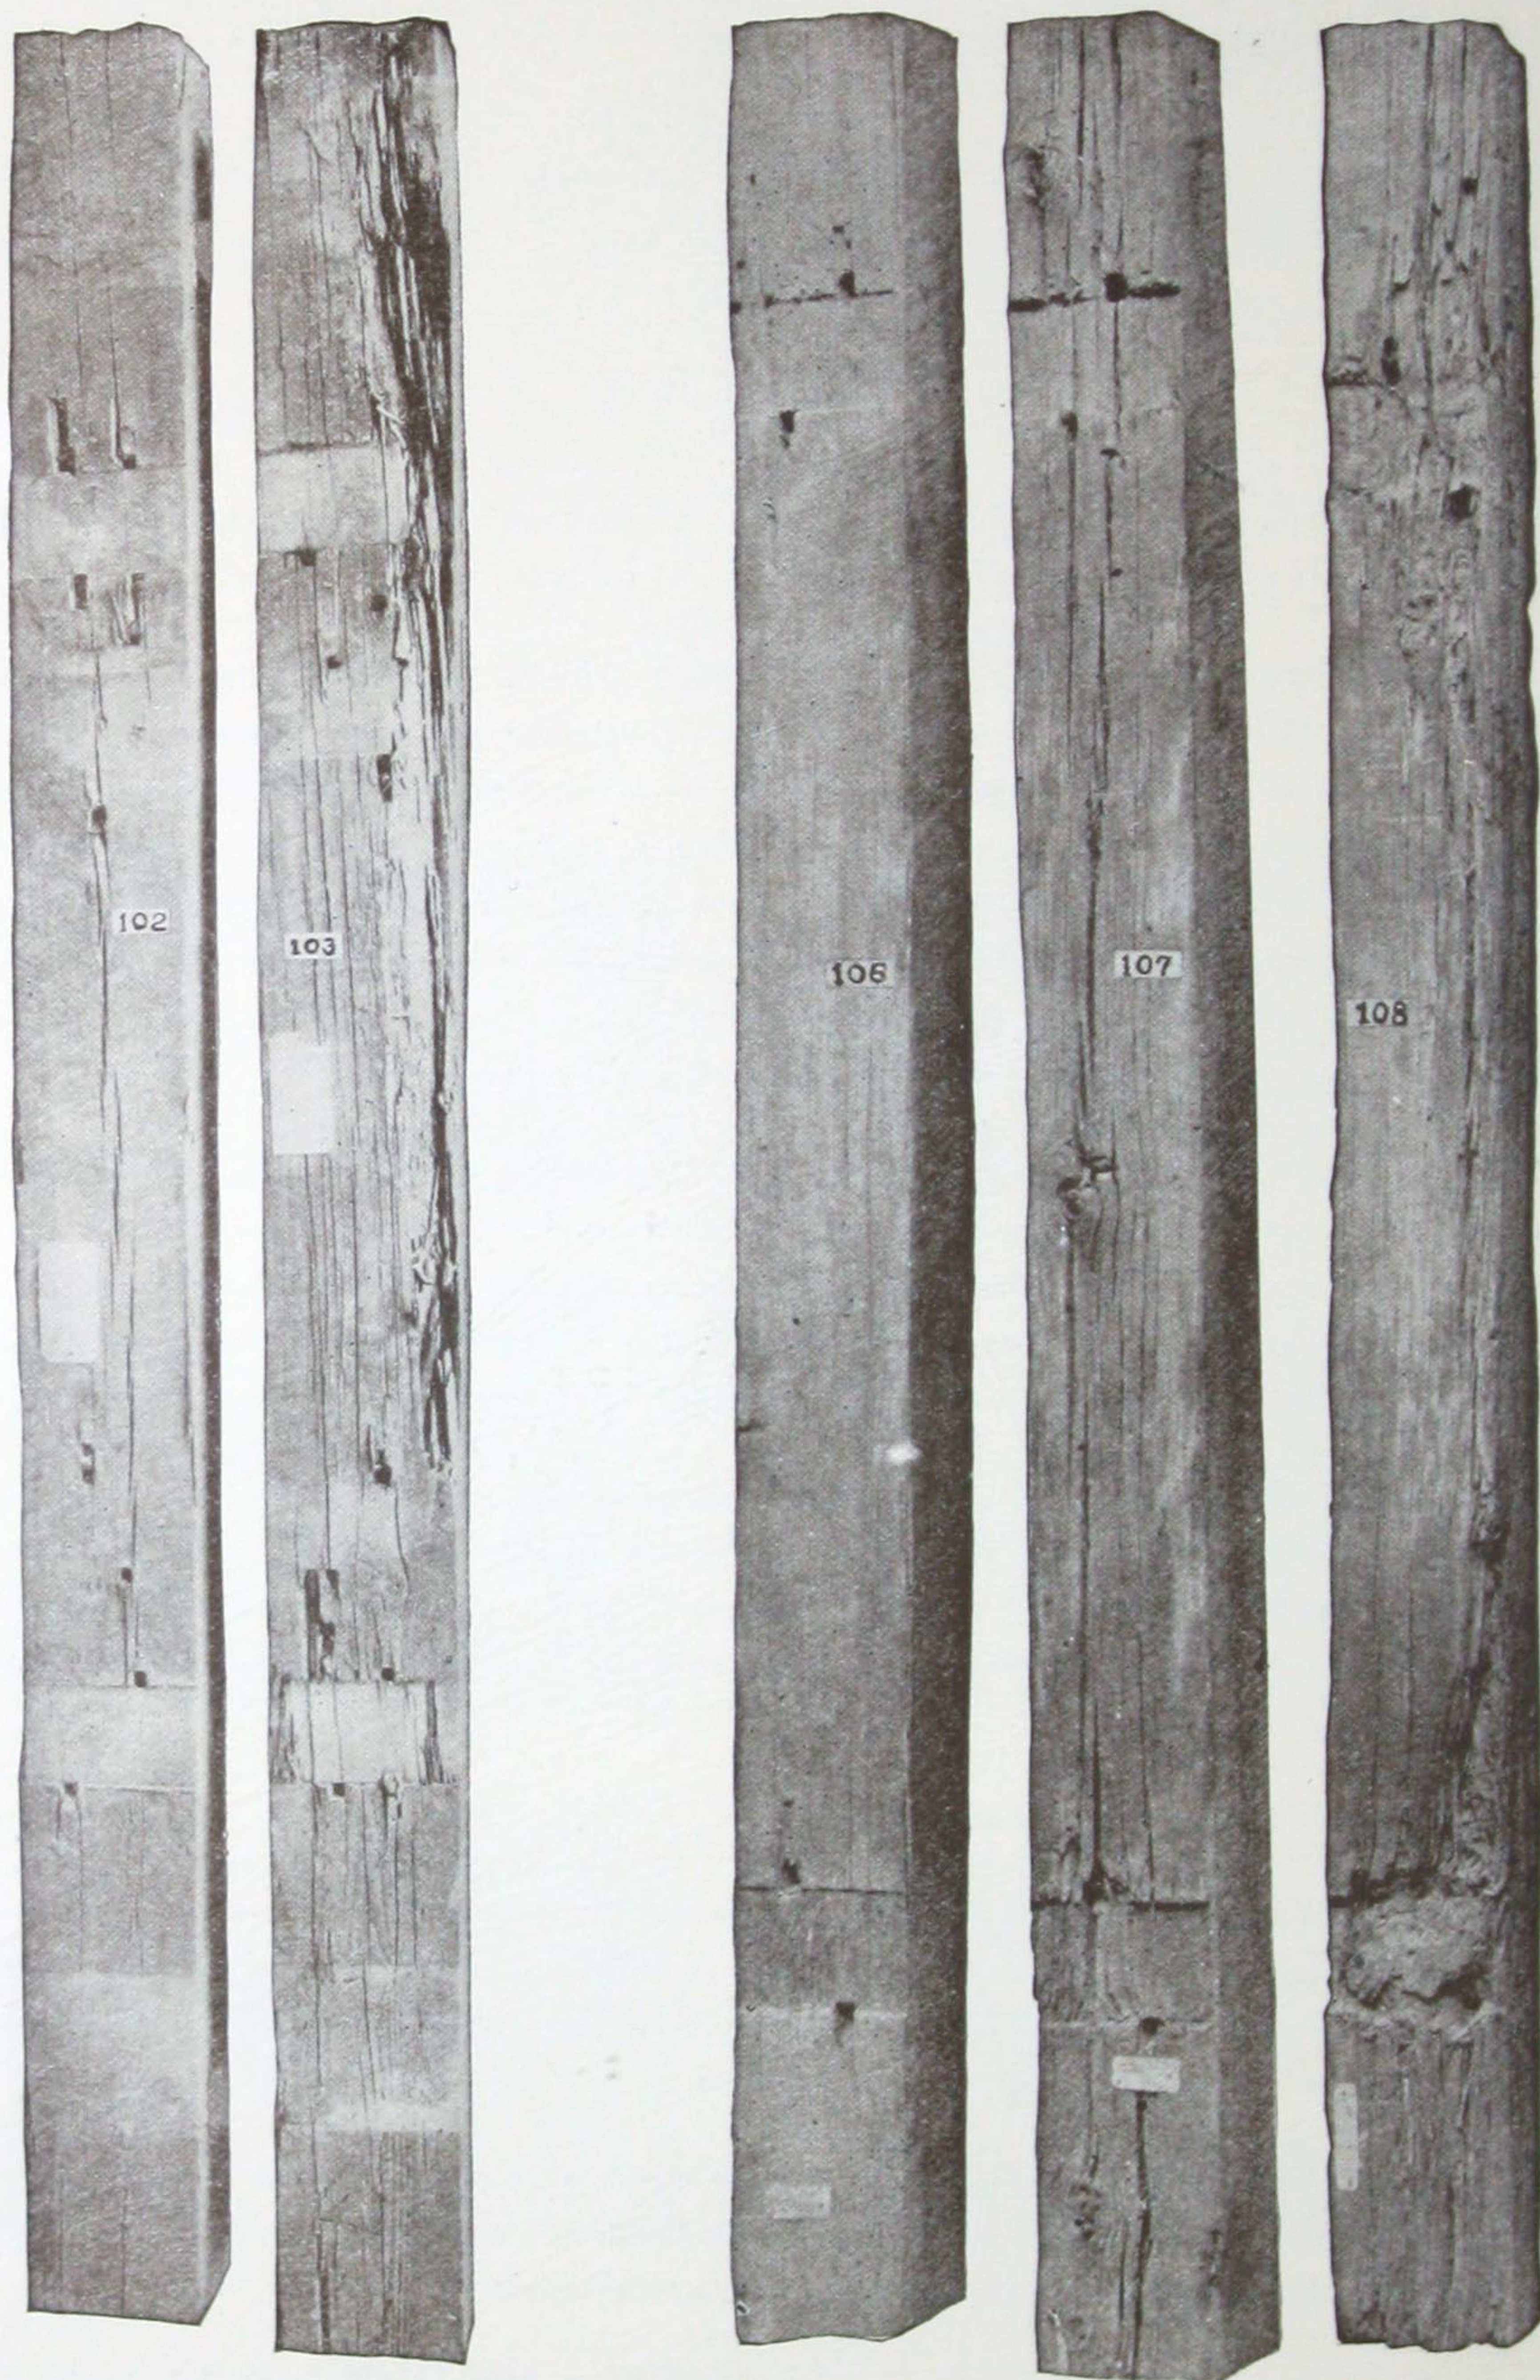
(102-103) Comparable yellow pine ties from Jamaica Bay Trestle of the Long Island Railroad Co. Placed green in January, 1907. No. 102 received two brush coats of heated Protexol. No. 103 was left untreated.

(106-107-108) Chestnut ties from Millville Traction Co., Millville, N. J. According to Mr. D. C. Lewis, General Manager, these ties were originally placed October 15, 1907. All were placed in the same kind of soil and under the same conditions in order to test the efficiency of wood preservatives. No. 108 was untreated, No. 107 was open tank treated with creosote and No. 106 received open tank treatment with our preservative. A colony of termites (white ants) was found in the tie treated with creosote. According to Mr. Lewis, "the ties treated with your preserver are doubtless good for another five years, while all the other ties are decayed,"

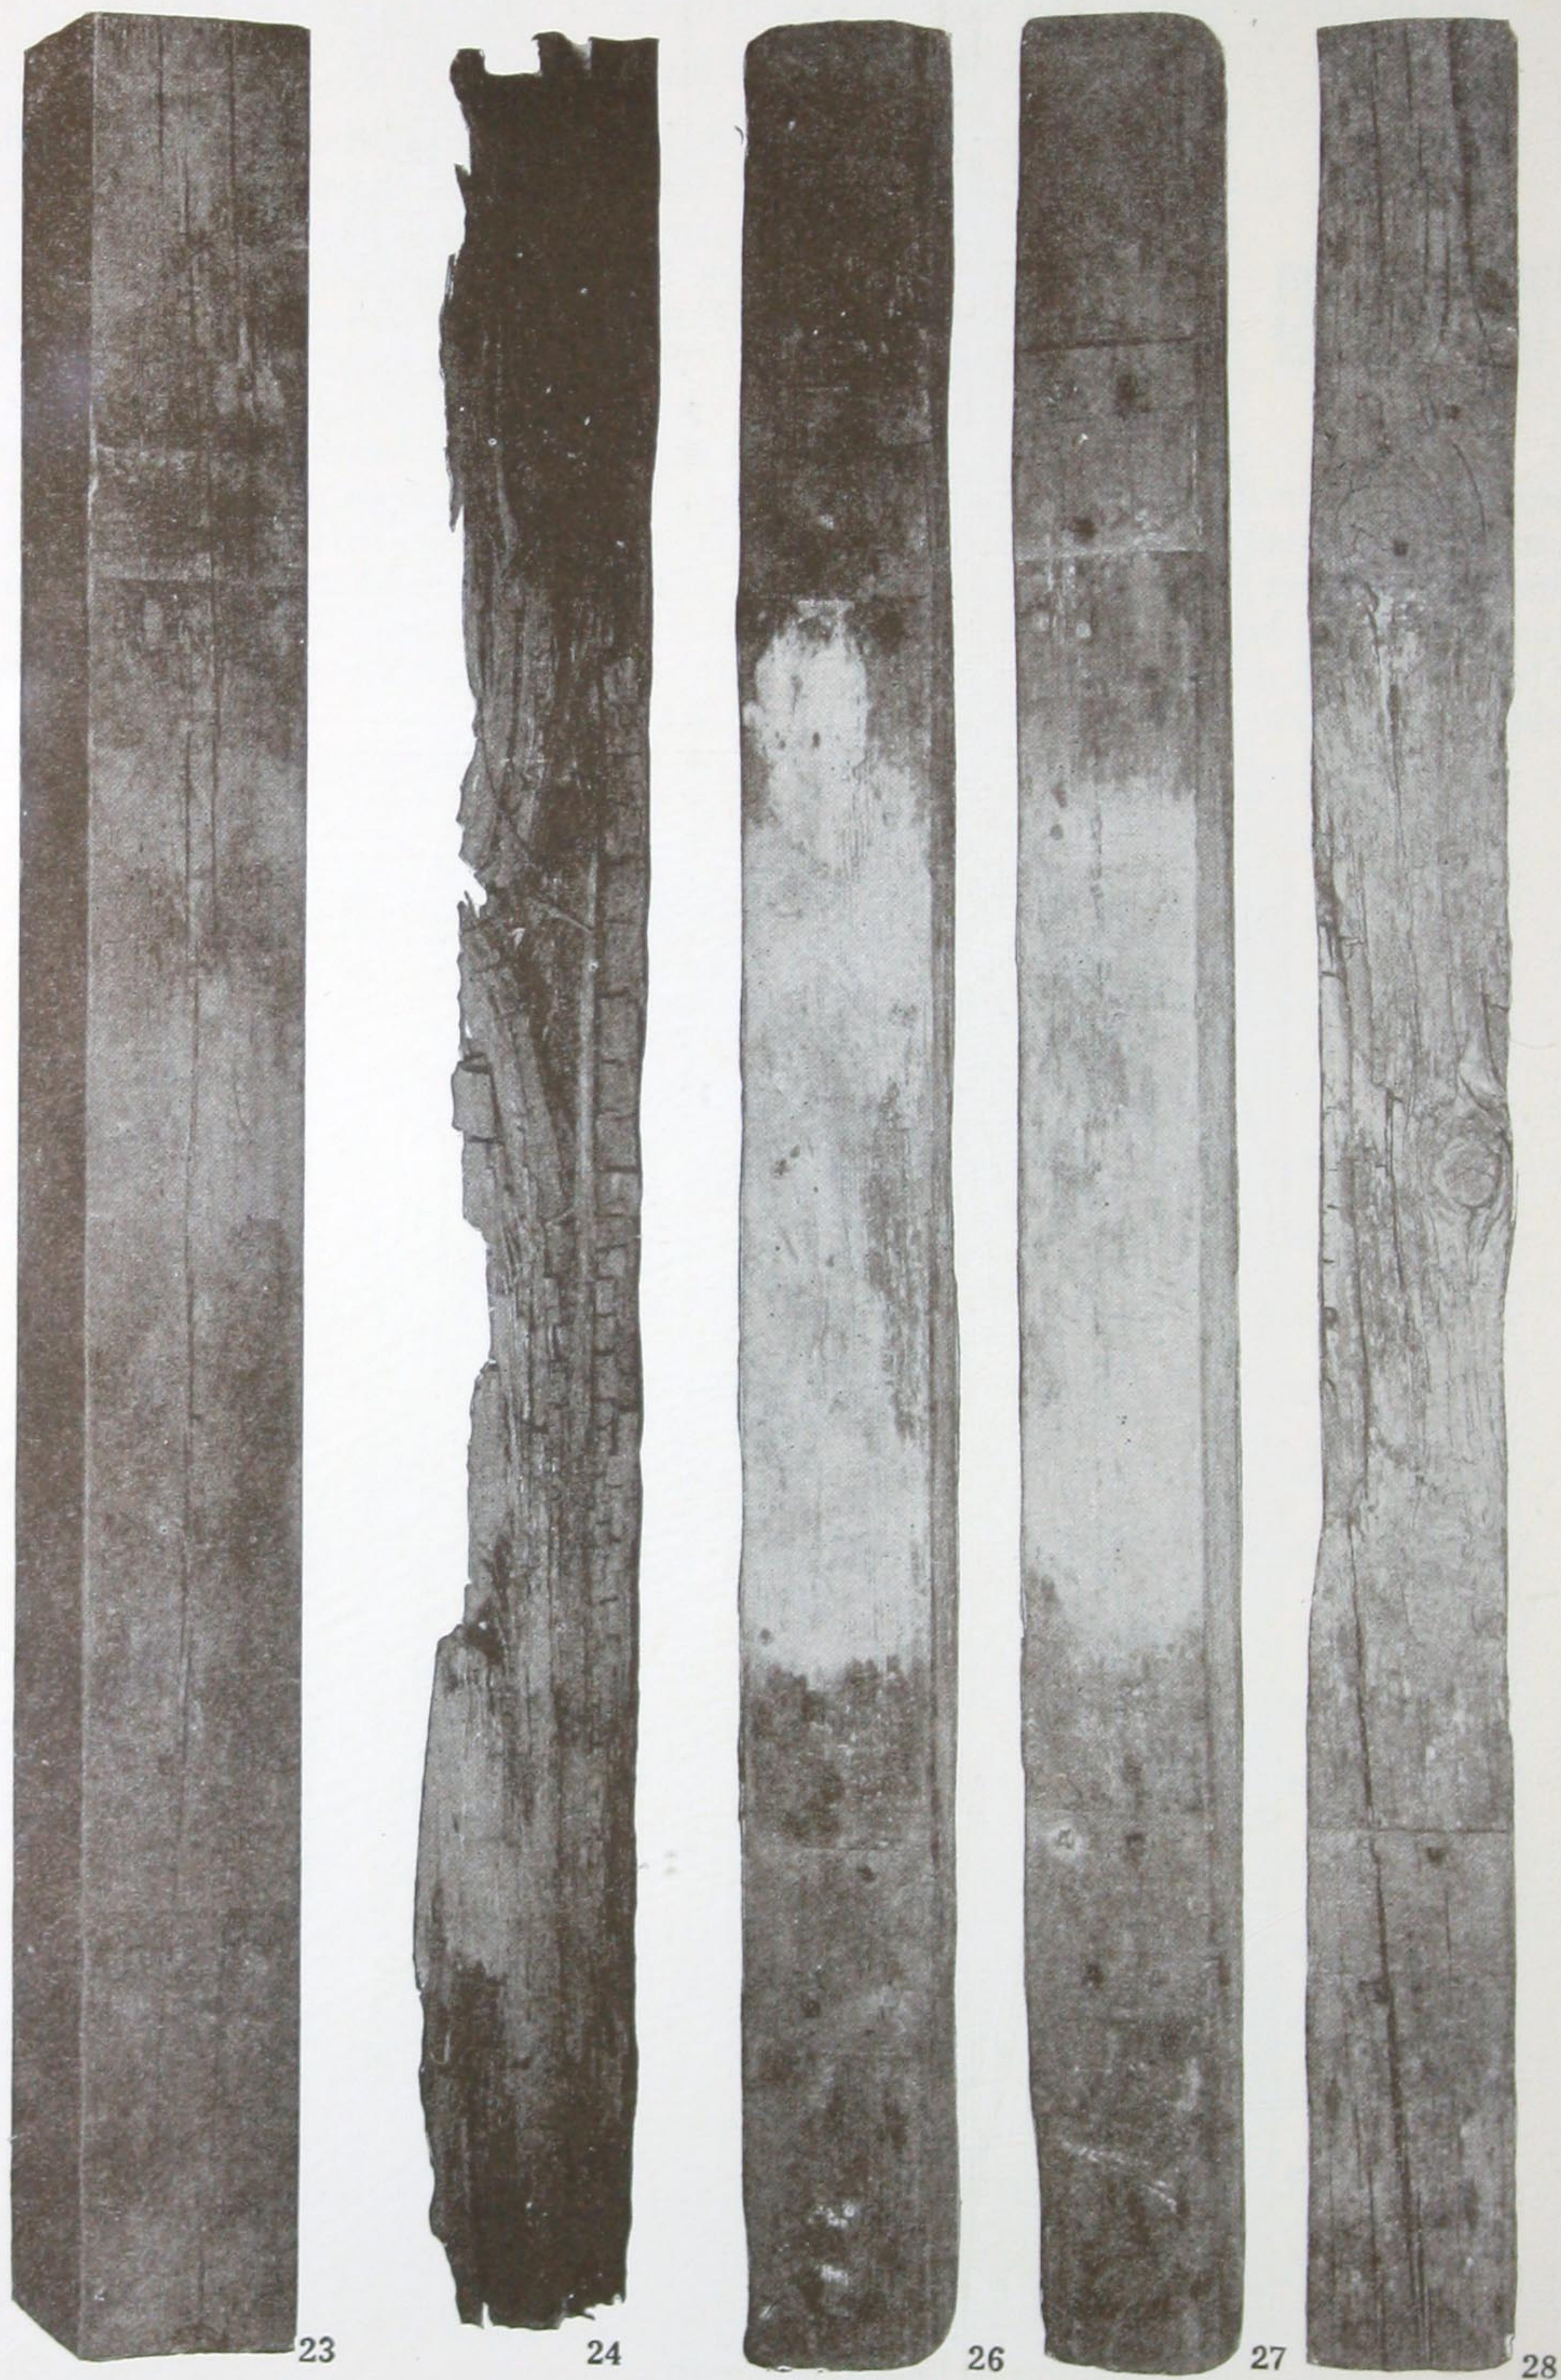
Specimens 23-24.—Comparable Western yellow pine ties from Denver City Tramway Co. Courtesy of Mr. John Evans, Chief Engineer. "No decay or rail wear and spikes holding firm on the ties that received a fifteen-minute immersion in your preservative."
 Nos. 26-27-28.—Contributed by Southern Pacific Co. Treated ties in service ten years, hard and well preserved. Railwear negligible under heavy power and traffic in main track. "They are superior to untreated fir, hold spikes in good shape and last longer by five years."

The case of the Denver City Tramway Co., specimens of whose treated and untreated ties are in our collection (see page 6) may be taken as an example of the operation of Table 1. The untreated ties were completely decayed in five years. Assuming that they cost 65c. each and that the labor of putting them into the track amounted to 20c. each, the total cost in the track was 85c. The annual charge at five per cent on 85c. for five years is 23.0975% of 85c. or 19.6c. Mr. Evans states that treatment with Protexol Wood Preservative cost them 16 to 18c., say 17c., and that the life of the treated ties is 10 years. The treated tie then costs them 85c. plus 17c., or \$1.02, and lasts 10 years. The annual charge, according to Table 1, will be 12.9505% of \$1.02, or 13.2c. as compared with 19.6c. for the untreated tie, an actual saving of 6.4c. per tie per year. If the ties are laid 18 inches center to center this means 3,520 ties per mile, or a saving of \$225.28 per mile per year. On the entire system of 31.874 miles of track this amounts to \$7,180.57 per year, which is equivalent to a four per cent dividend on \$179,514.

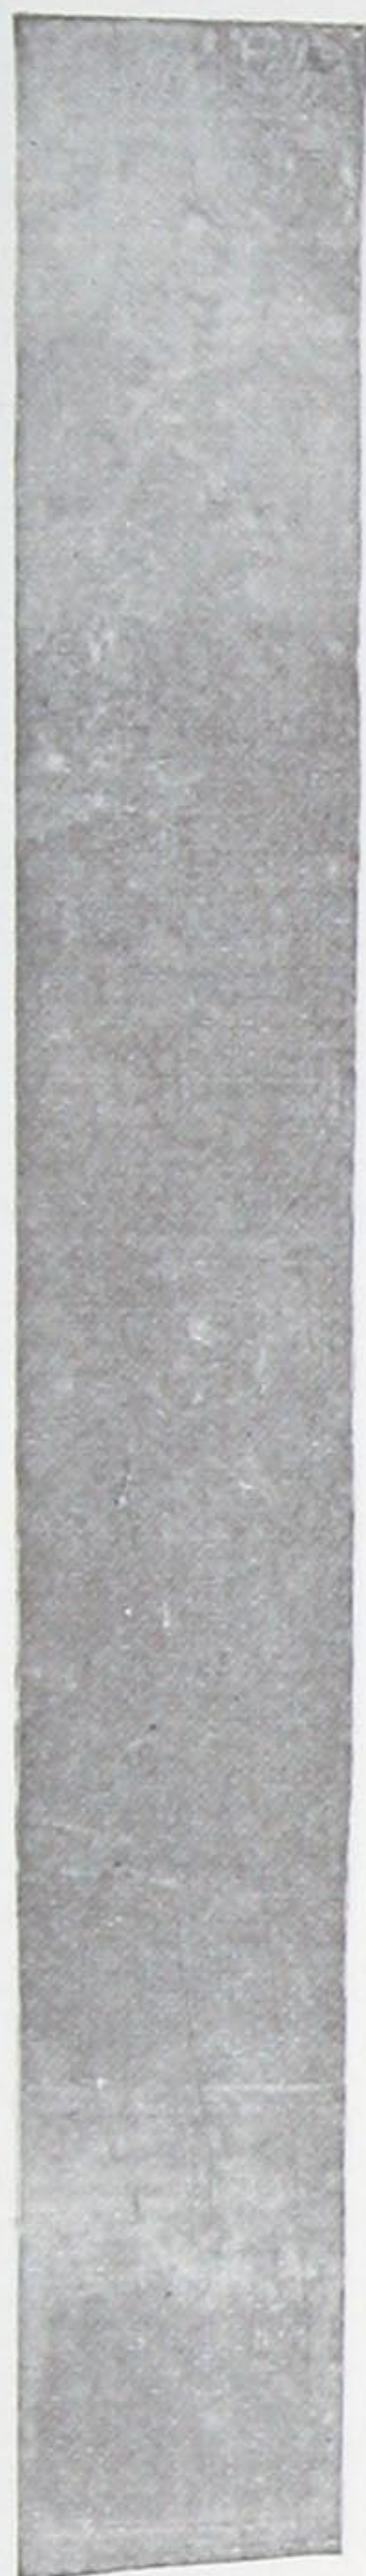
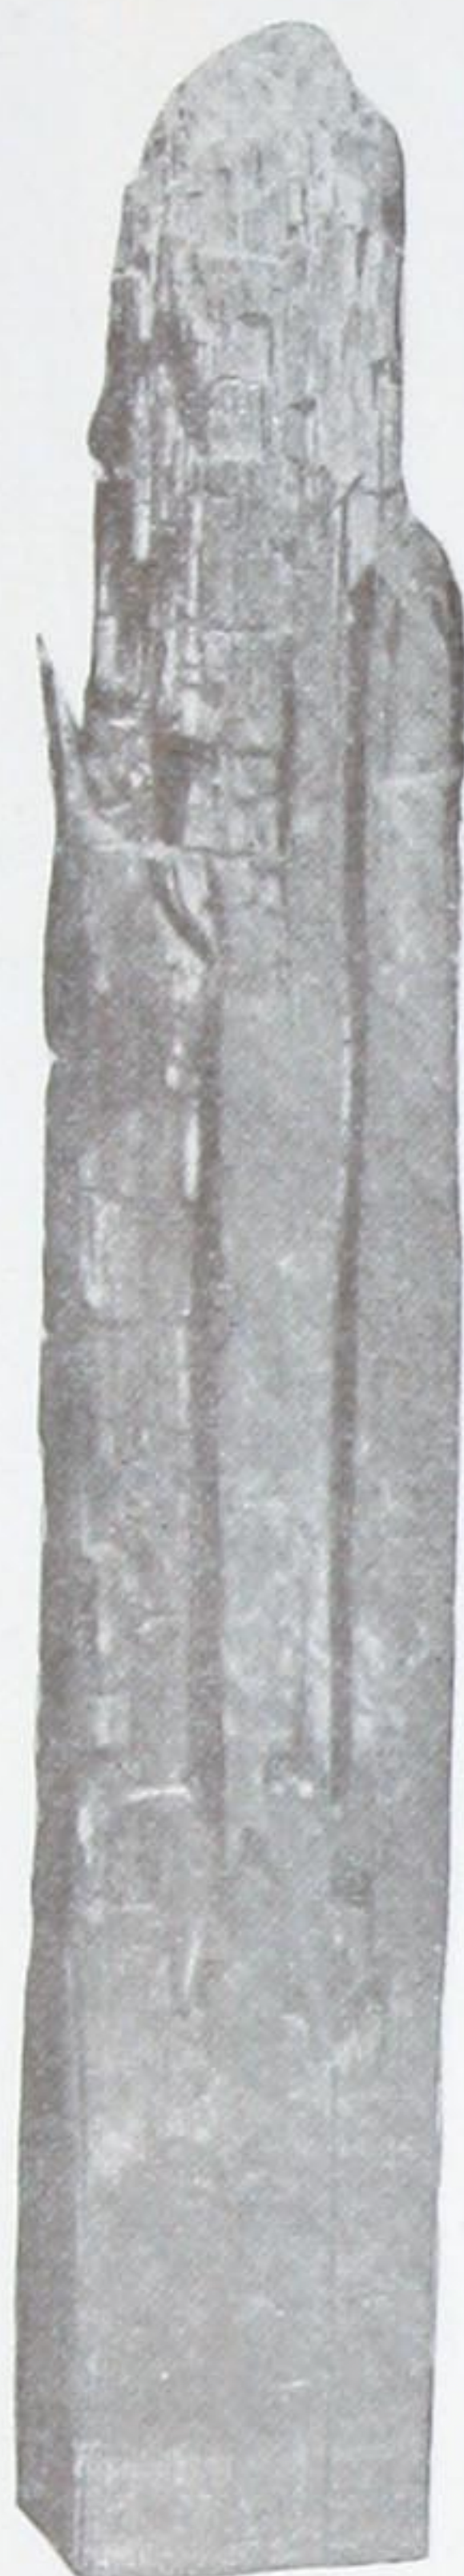
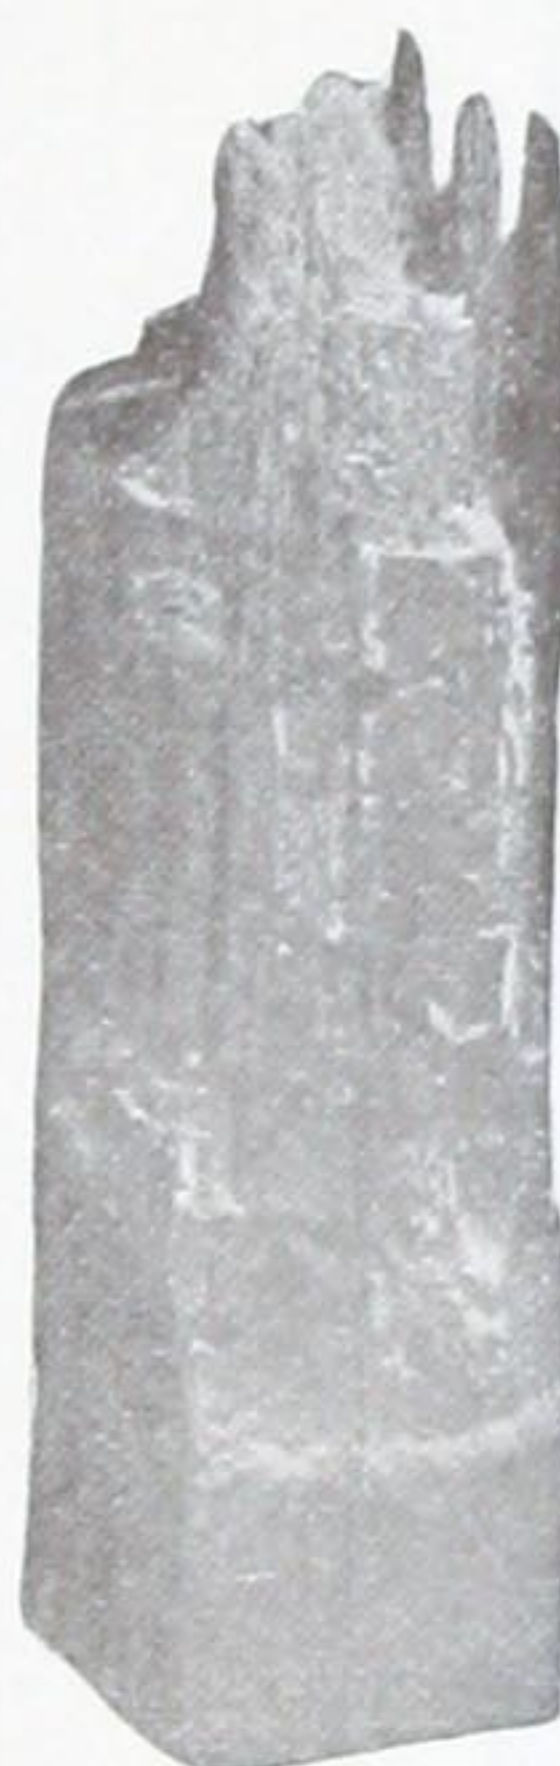
Nos. 32-33-34.—Co-operation of C. E. Smith, Bridge Engineer, Mo. Pac. Ry. Co. "No. 32 butt of post immersed for ten minutes in a tank of boiling preservative. No. 33 painted instead of dipped with one coat of your preservative one foot below and one foot above ground. No. 34, no treatment. All three of long leaf yellow pine installed in stock pens at Pueblo, Colo., in the same location under identical conditions in 1902. All cut off one foot above ground line."

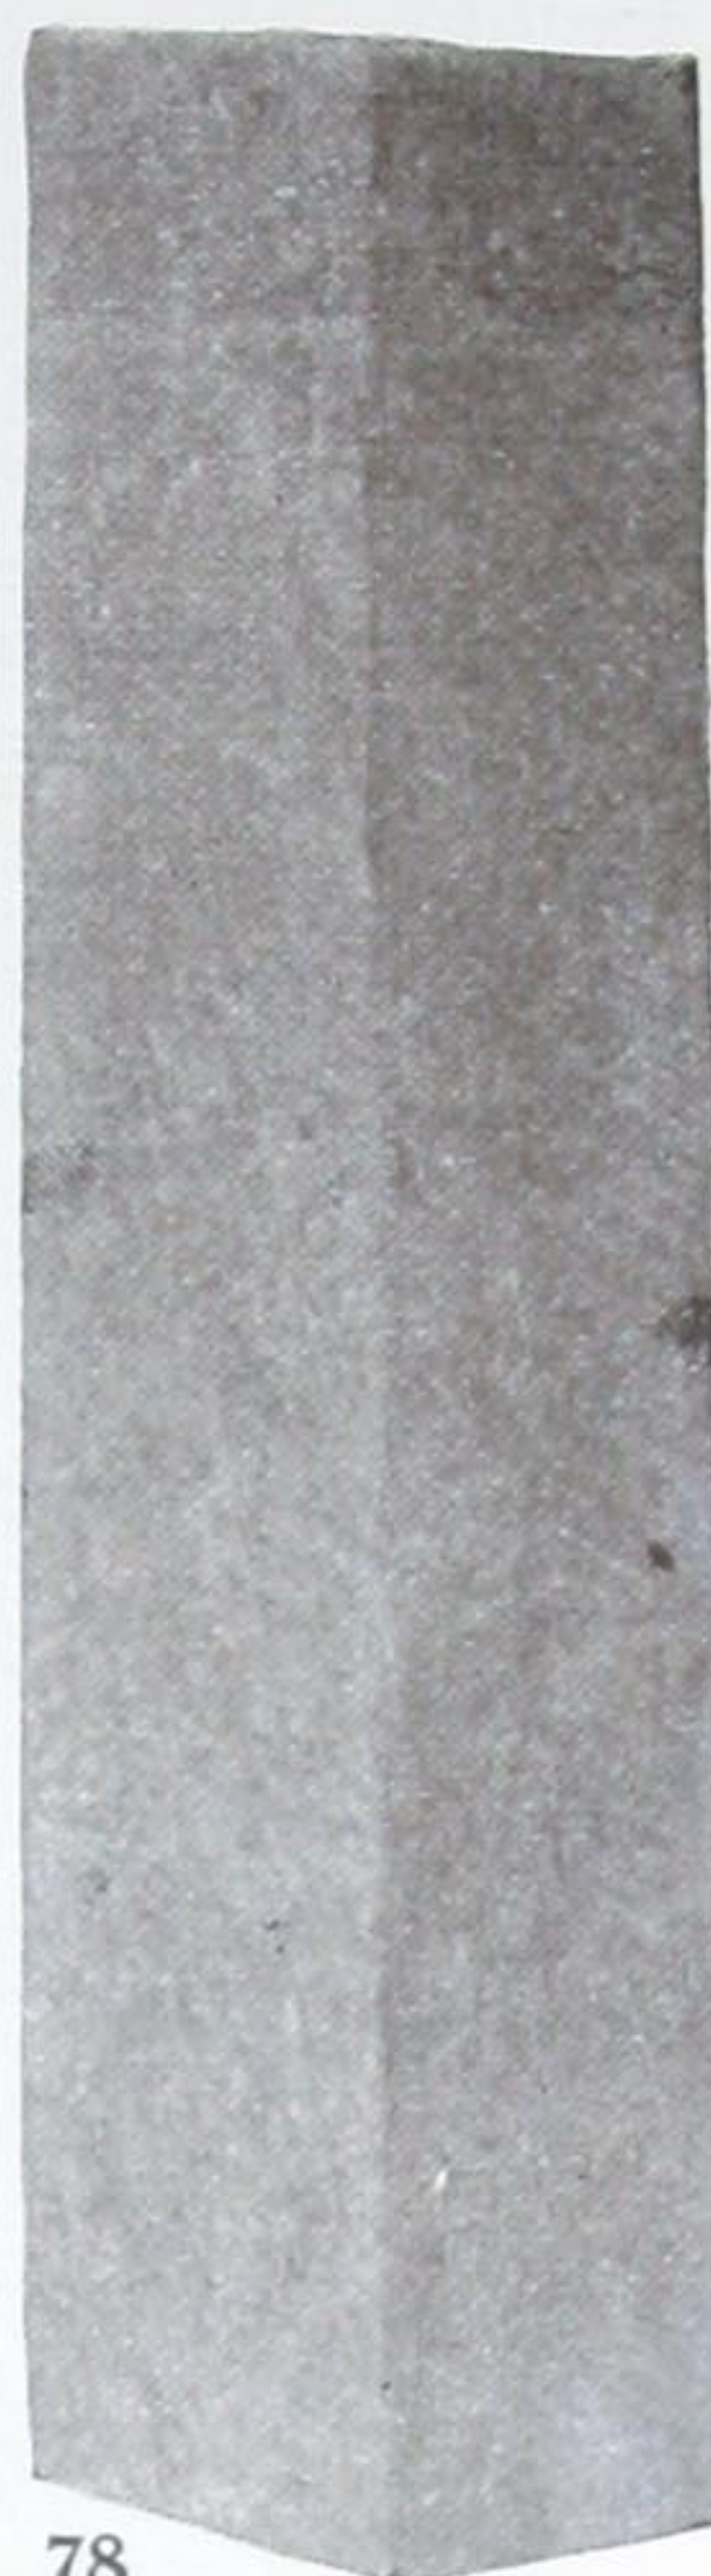
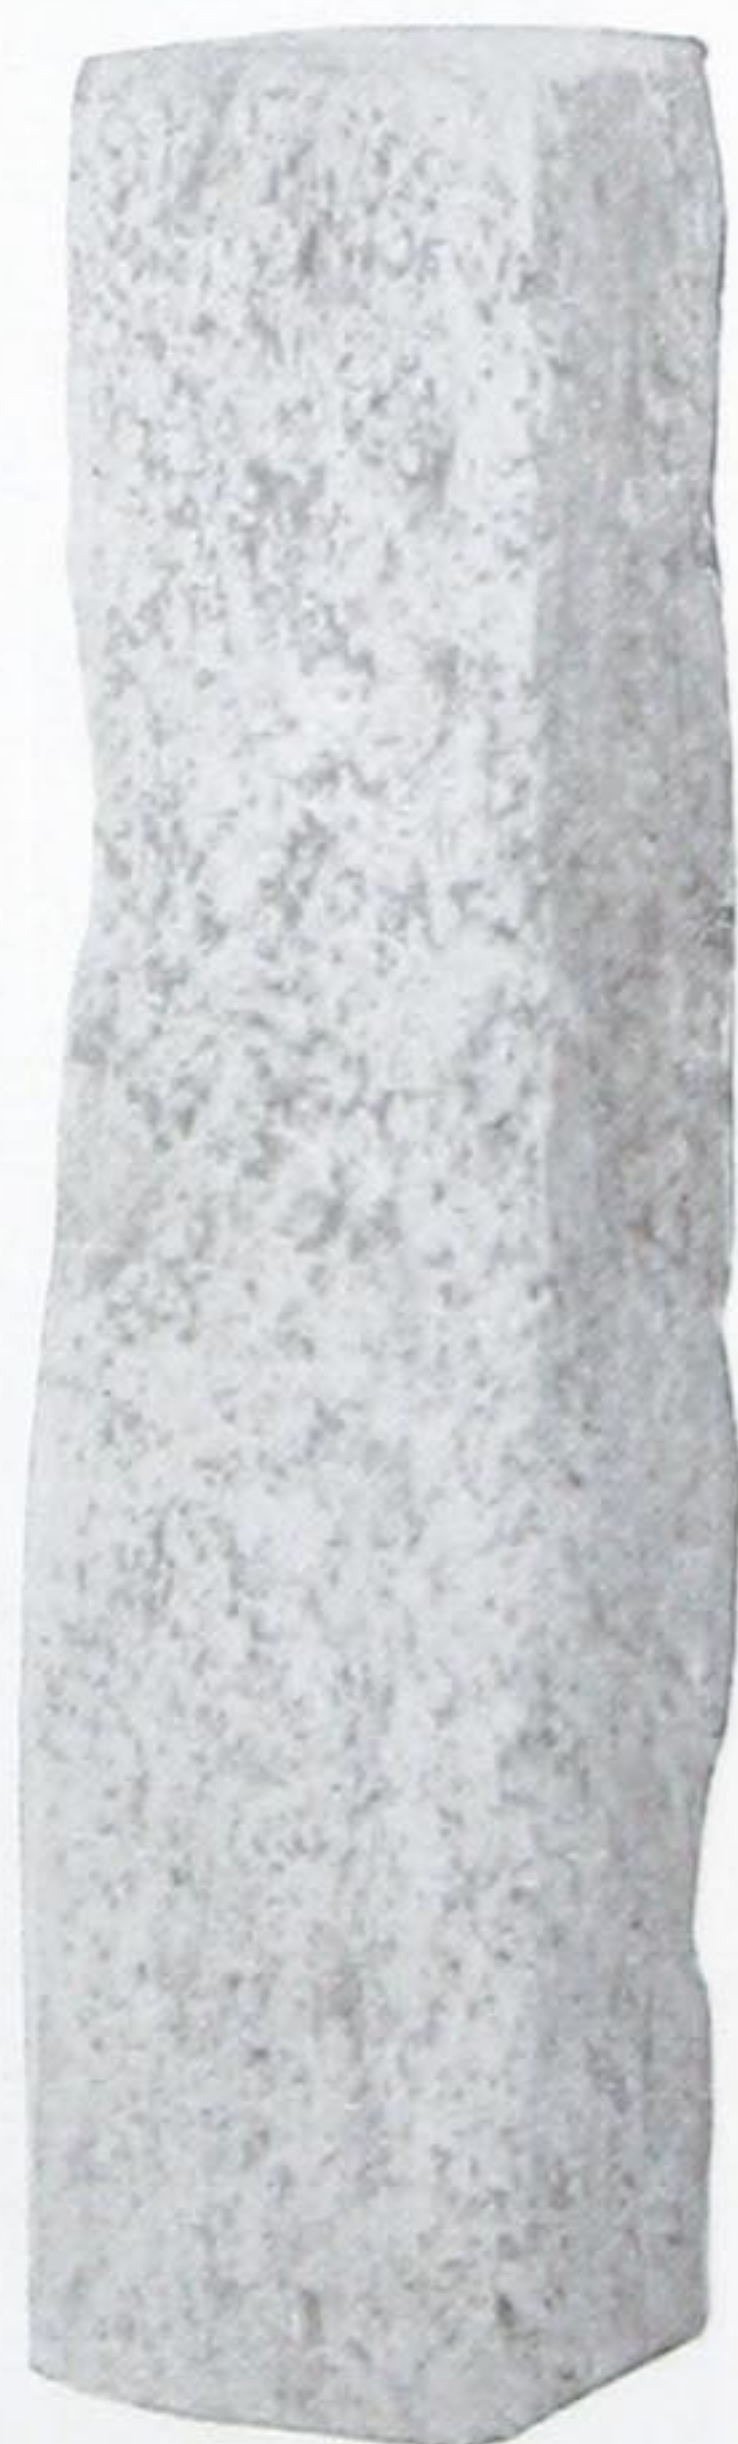
Two specimens of yellow pine bulkhead timber from breakwater of the Metropolitan Coal Co., South Boston, Mass. When removed treated timber (No. 78) was perfectly sound, while No. 79, untreated, was completely worm eaten. Courtesy of Mr. Fred Hodgson, Chief Engineer, Massachusetts Board of Harbor and Land Commission.

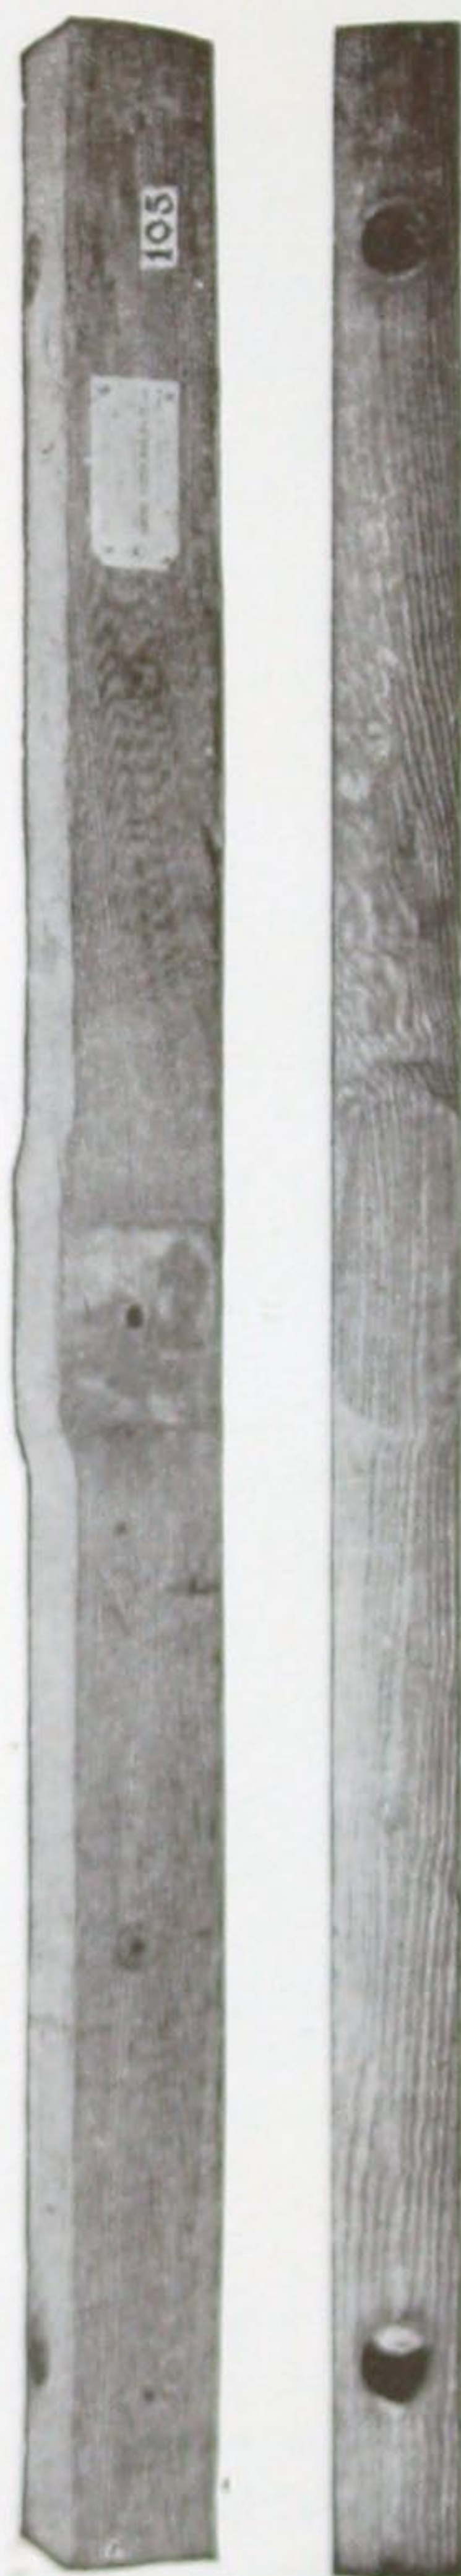
From Lyons Lines of Empire United Railways, constructed by J. G. White & Co. Untreated arms removed in five years. Treated arm after 10 years service. Courtesy of Mr. H. C. Prather, Asst. Gen. Mgr., Syracuse, N. Y.

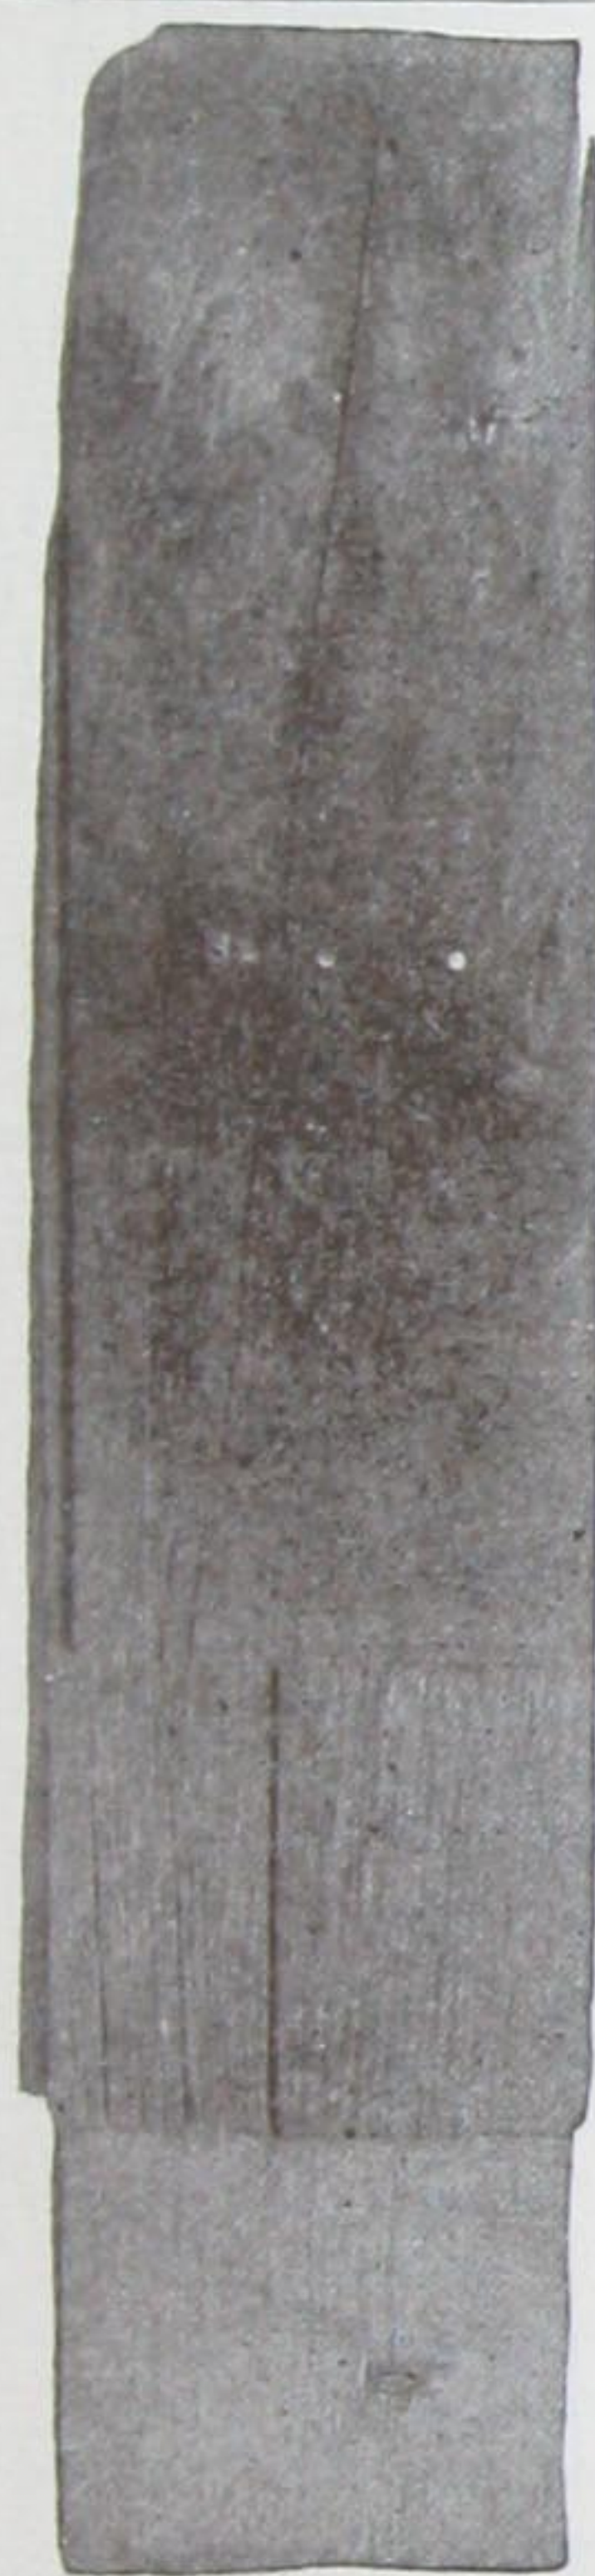
No. 53.—Mr. Wm. P. Jessup, Building Contractor, 55 Adams St., Bridgeport, Conn., re-shingled roof on his residence twenty-four (24) years ago using red cedar. Roof was painted with one coat of our preservative and is in excellent condition now.

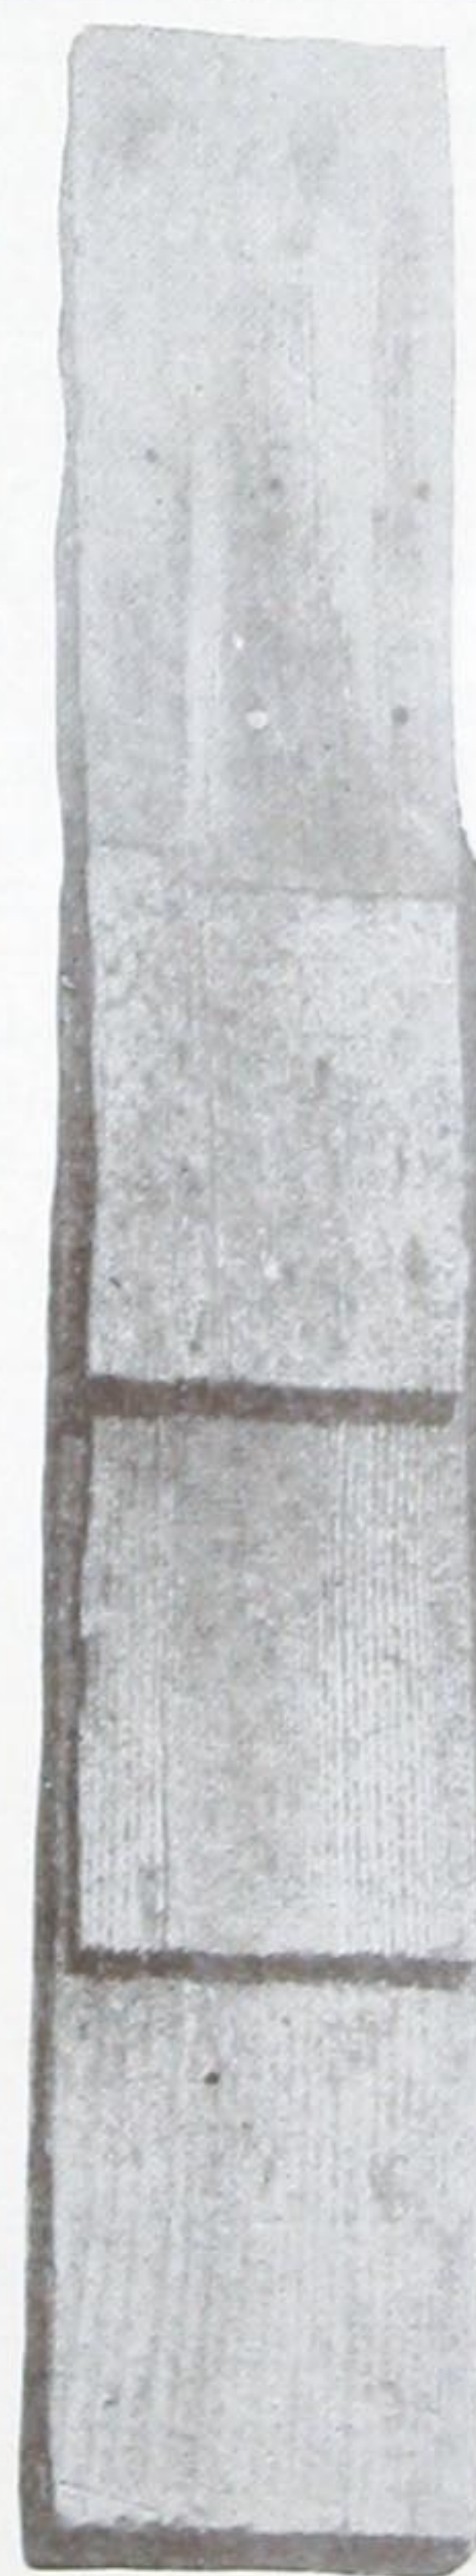
No. 54.—Cypress shingles laid and brush-treated with one coat in 1892. No rot or decay found in specimens, and all shingles on roof are to-day in excellent condition. Specimens from Christ Weinlaeder, Drayton, N. D.
